MPGD Photon Detector Upgrade for COMPASS RICH

Gergő Hamar

Instrumentation for Colliding Beam Physics
Budker INP, Novosibirsk, 2017

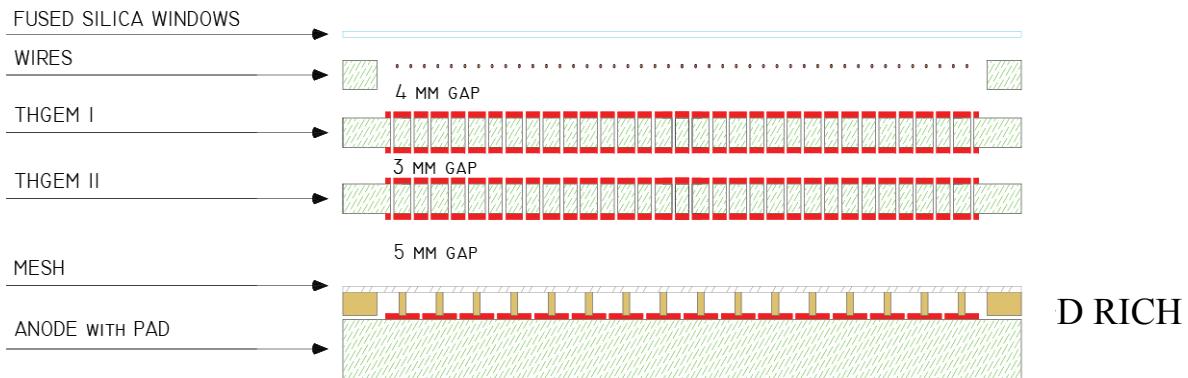
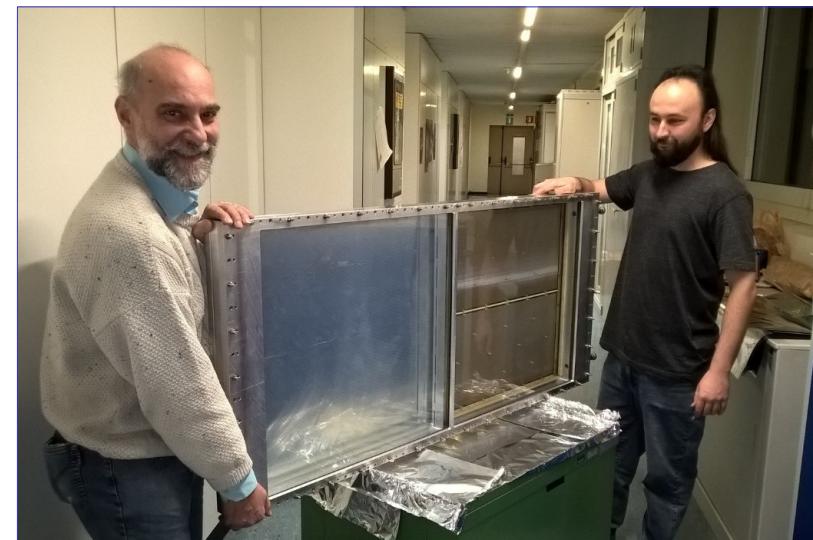
The Hybrid Detector for COMPASS RICH

- **Double ThickGEM + Bulk Micromegas**

- Photo conversion** : first THGEM coated with CsI

- High gain** for single photo-electron detection

- Low Ion BackFlow** : MM + staggered THGEMs => ~ 2%

- THGEMs

- Producer: ELTOS Italy ; Size: 600x300 mm²

- Parameters: thickness:400μm, pitch:800μm, hole:400μm, rim:10μm,

- Bulk MM

- Capacitive readout**, discrete resistors 500MOhm, Mesh on ground

- Producer: PCB at TVR, bulk MM at CERN; Size: 600x300 mm²

- Padplane: 8x8 mm² padsize

- Readout electronics: APV25 (+DAQ chain)

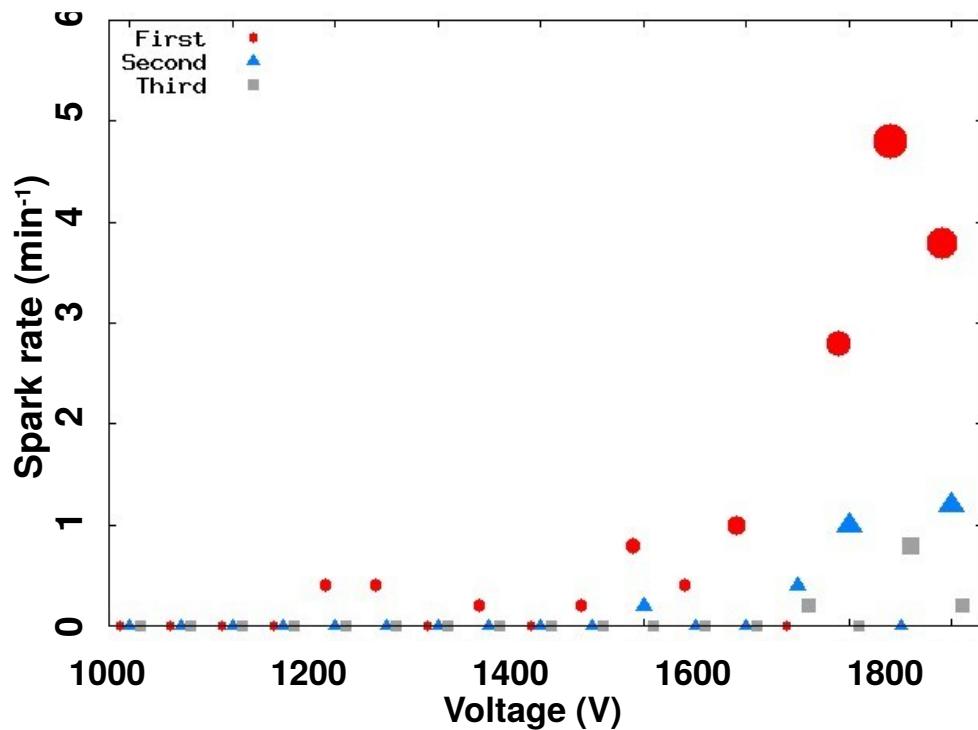
Reproducibility & Cleaning sparks in Paschen test

- ThickGEMs
 - Material selection → uniform thickness
 - Polishing → smooth copper edges
 - **Paschen test in N₂**
 - **Discharge test in Ar-CO₂**

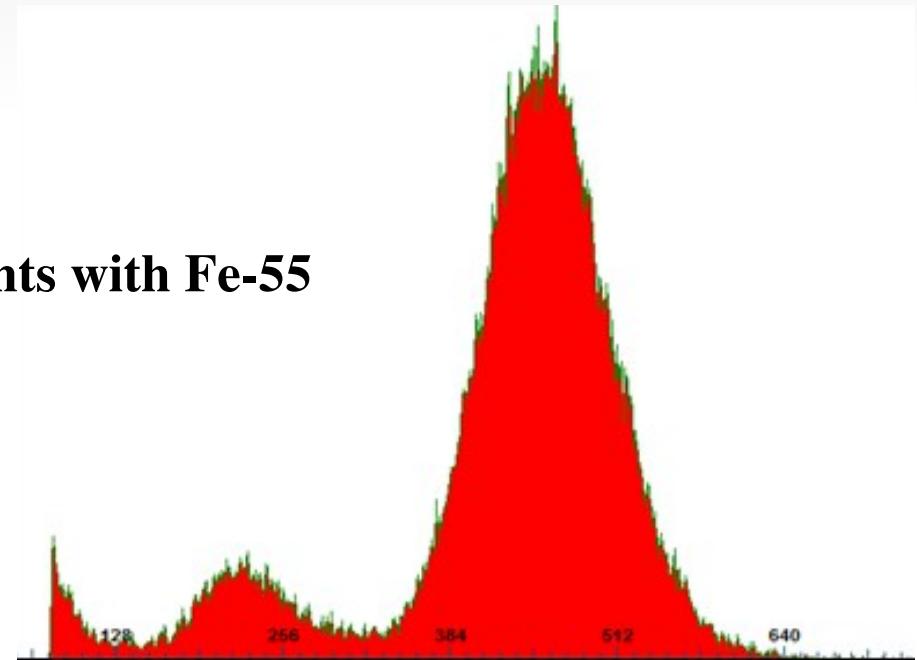
- ThickGEMs
 - Material selection → uniform thickness
 - Polishing → smooth copper edges
 - Paschen test in N₂
 - Discharge test in Ar-CO₂
 - **Gain and uniformity measurements with X-rays**
 - Test after gold plating
 - CsI coating's QE measurement
- Micromegas
 - Electrical check of HV pads
 - **Gain and uniformity measurements with Fe-55**

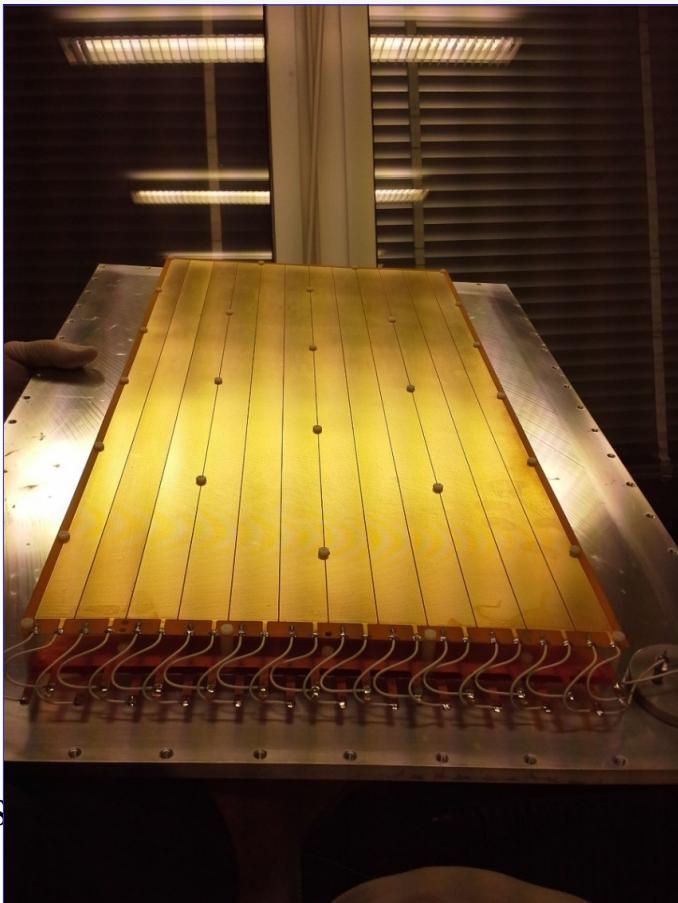
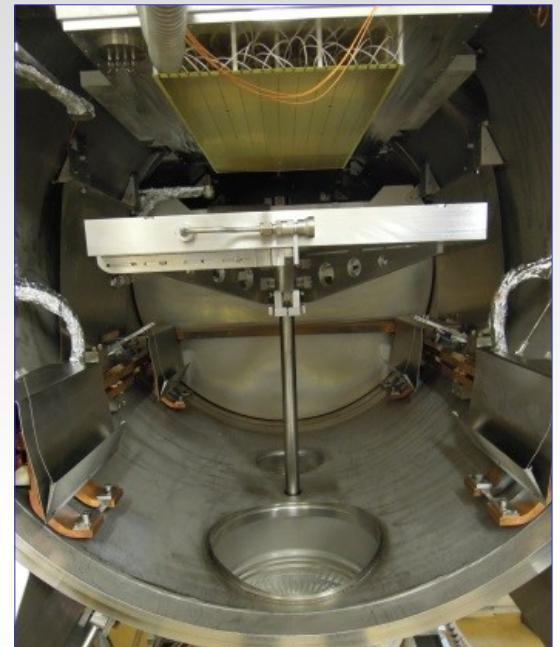
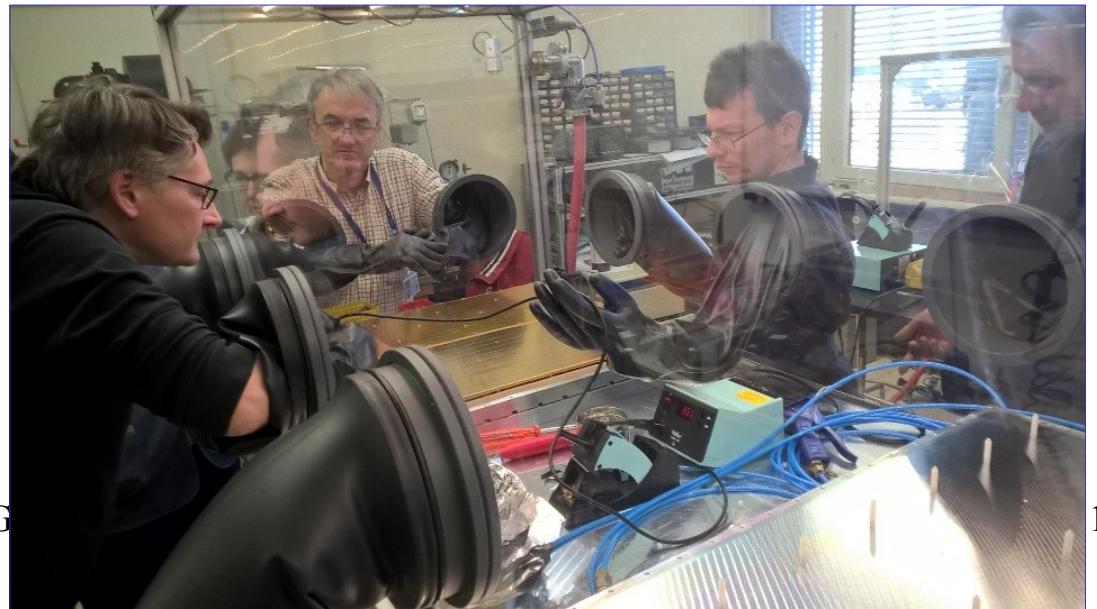
... and the CsI

- Revive the **CsI coating system** at CERN (non-trivial)
proper gold surface, cleanliness, ...
- Surface with holes in it ...
- **Measured QE** ~ expected one x0.7-1.0
- Coated THGEMs assembled

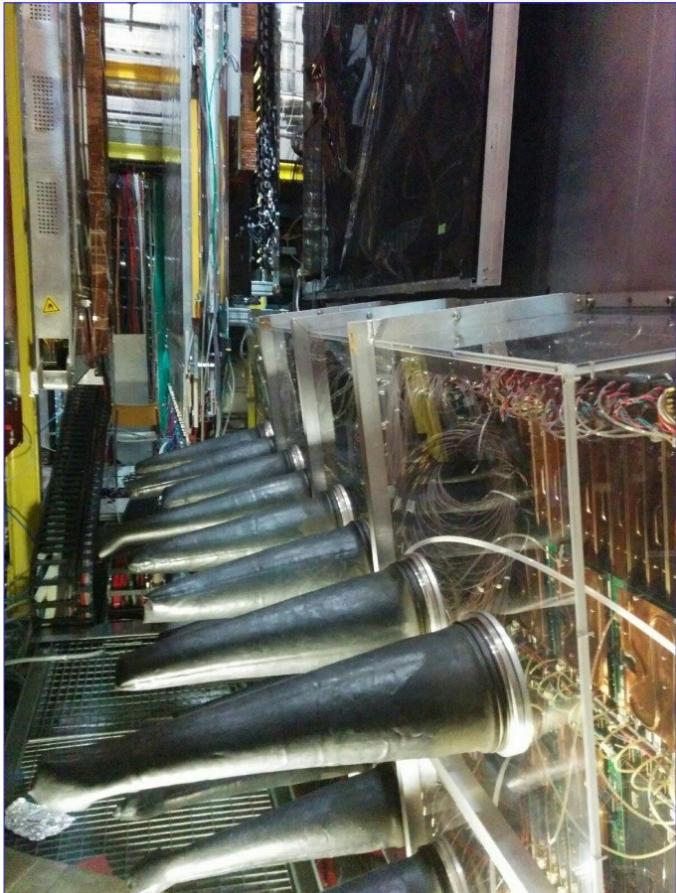
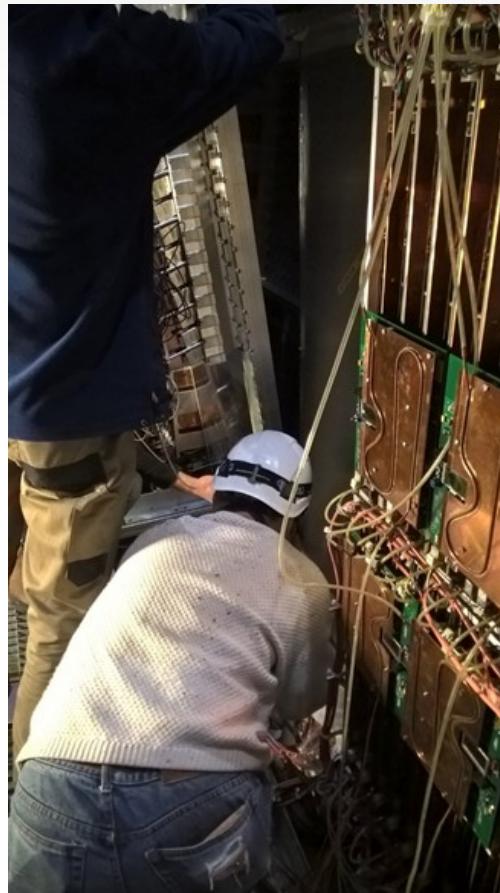
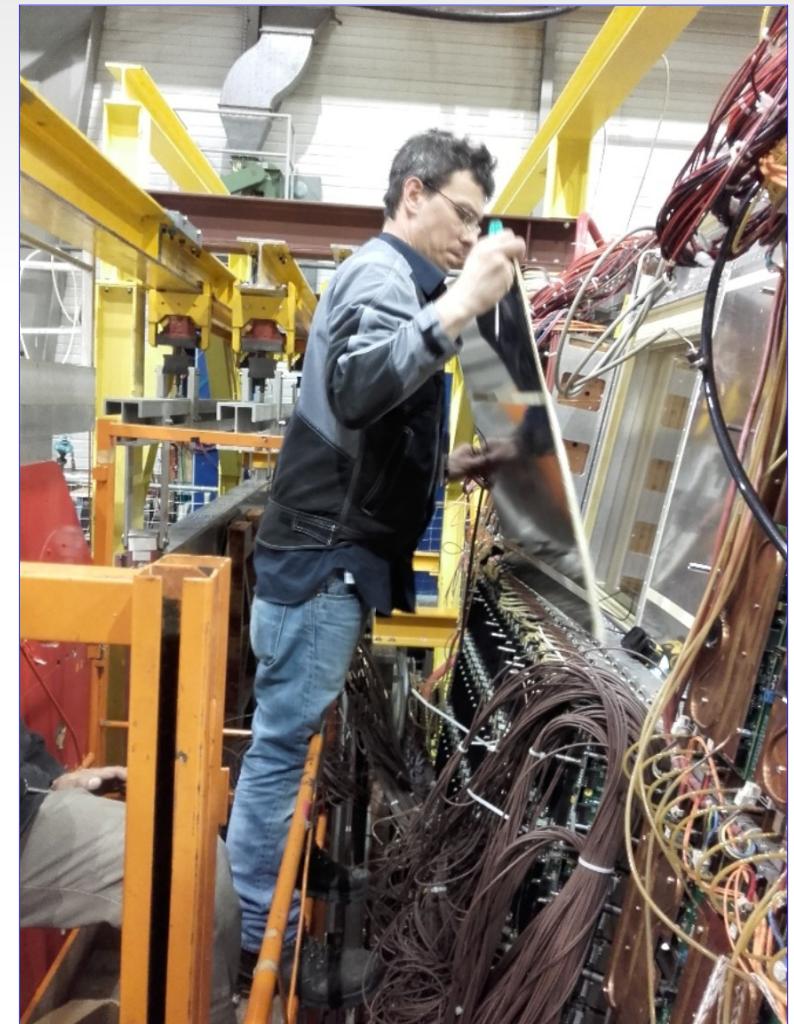
Mounting

- MAPMT part remounted
- Hybrids: due to the CsI → mounting is a **glove box** operation
- + HighVoltage (new system)
- + Electronics (used system)
- + Cooling (upgraded)

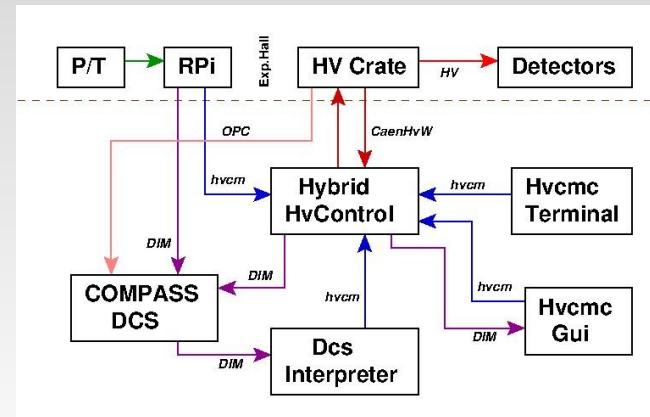
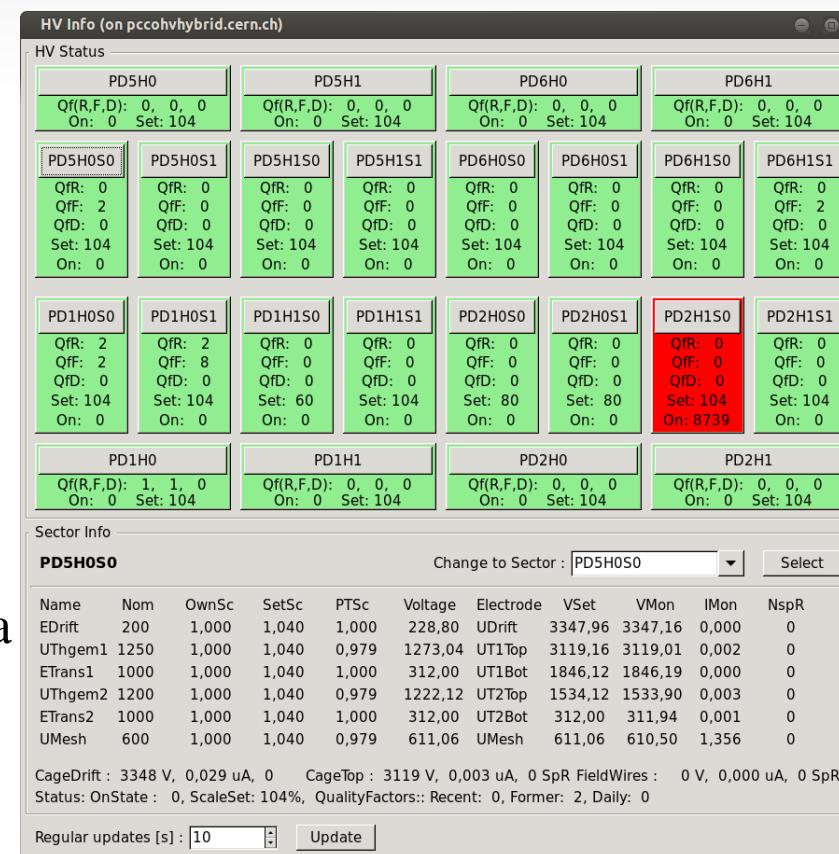
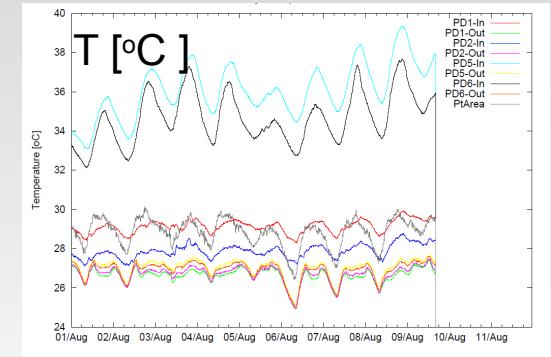
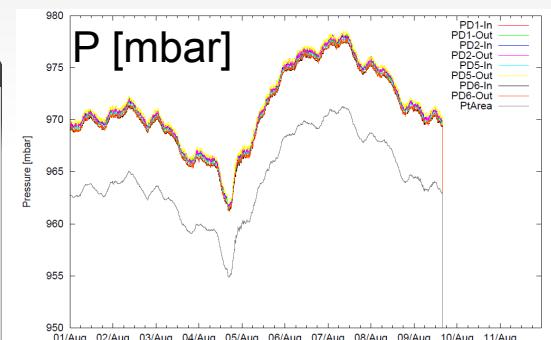
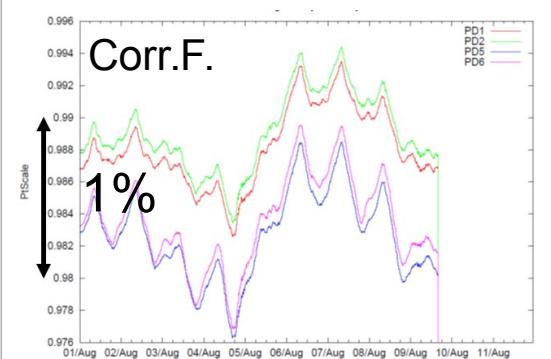
HV System

- **Custom made HV system**
(C++, wxWidgets)
- Coop. with **COMPASS DCS**
- **Correction wtr P/T**
in amplifier regions
- "OwnScale" to finetune
for **uniformity**
- **Log** with 1 Hz
- **Spark detection**
- Autodecrease HV
if too many sparks
- Interaction via: GUI,
DCS, DIM, Msg
- Gain variation in lab
 $40\% \rightarrow 10\%$
Needs to be verified
on the CompassData
- HV Units from CAEN
SY2745 (x2): HvCrate
A7030 (x2): +3kVx12ch
A1561 (x8): -6kVx12ch

P/T: ~1% →
Gain: ~40%²⁰

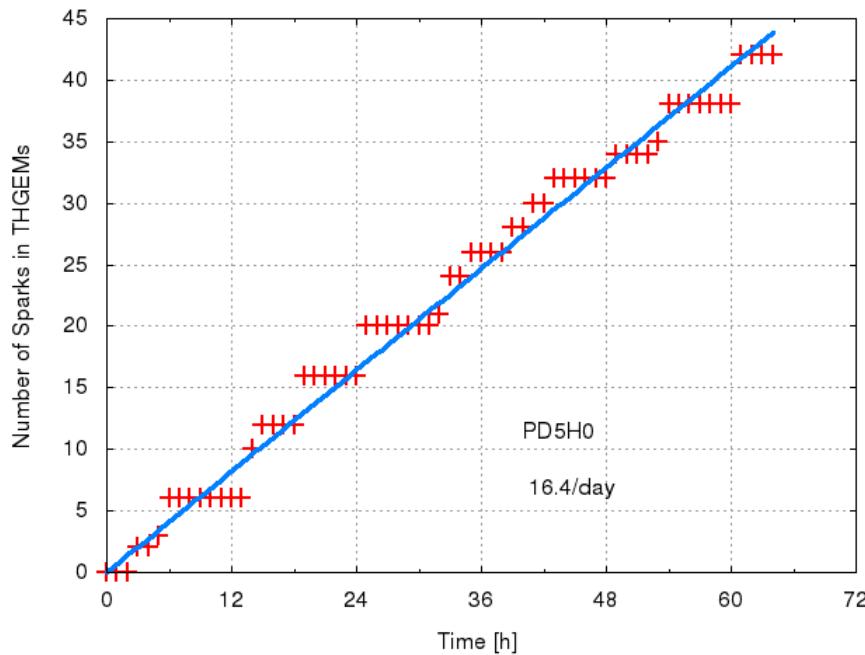
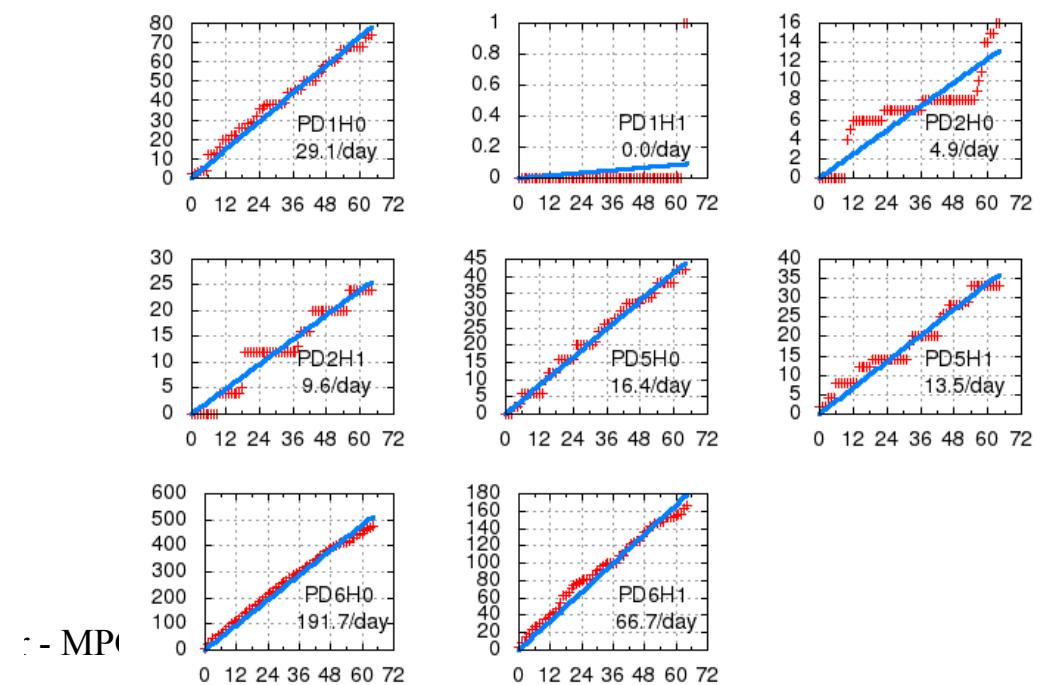
Sparks in the THGEMs

- Log of HV and autodecrease worked well
- **Spark rate** seems to be **constant** on all Sectors (two half THGEMs)
- Bad sectors : three (3/16) cannot be kept at reasonable voltage for long segment-level investigation after the End of RUN
Priority was the commissioning of the **working Sectors**
- Several correlated sparks on neighbouring sectors/chambers have been seen
→ most probably induced by cosmic showers

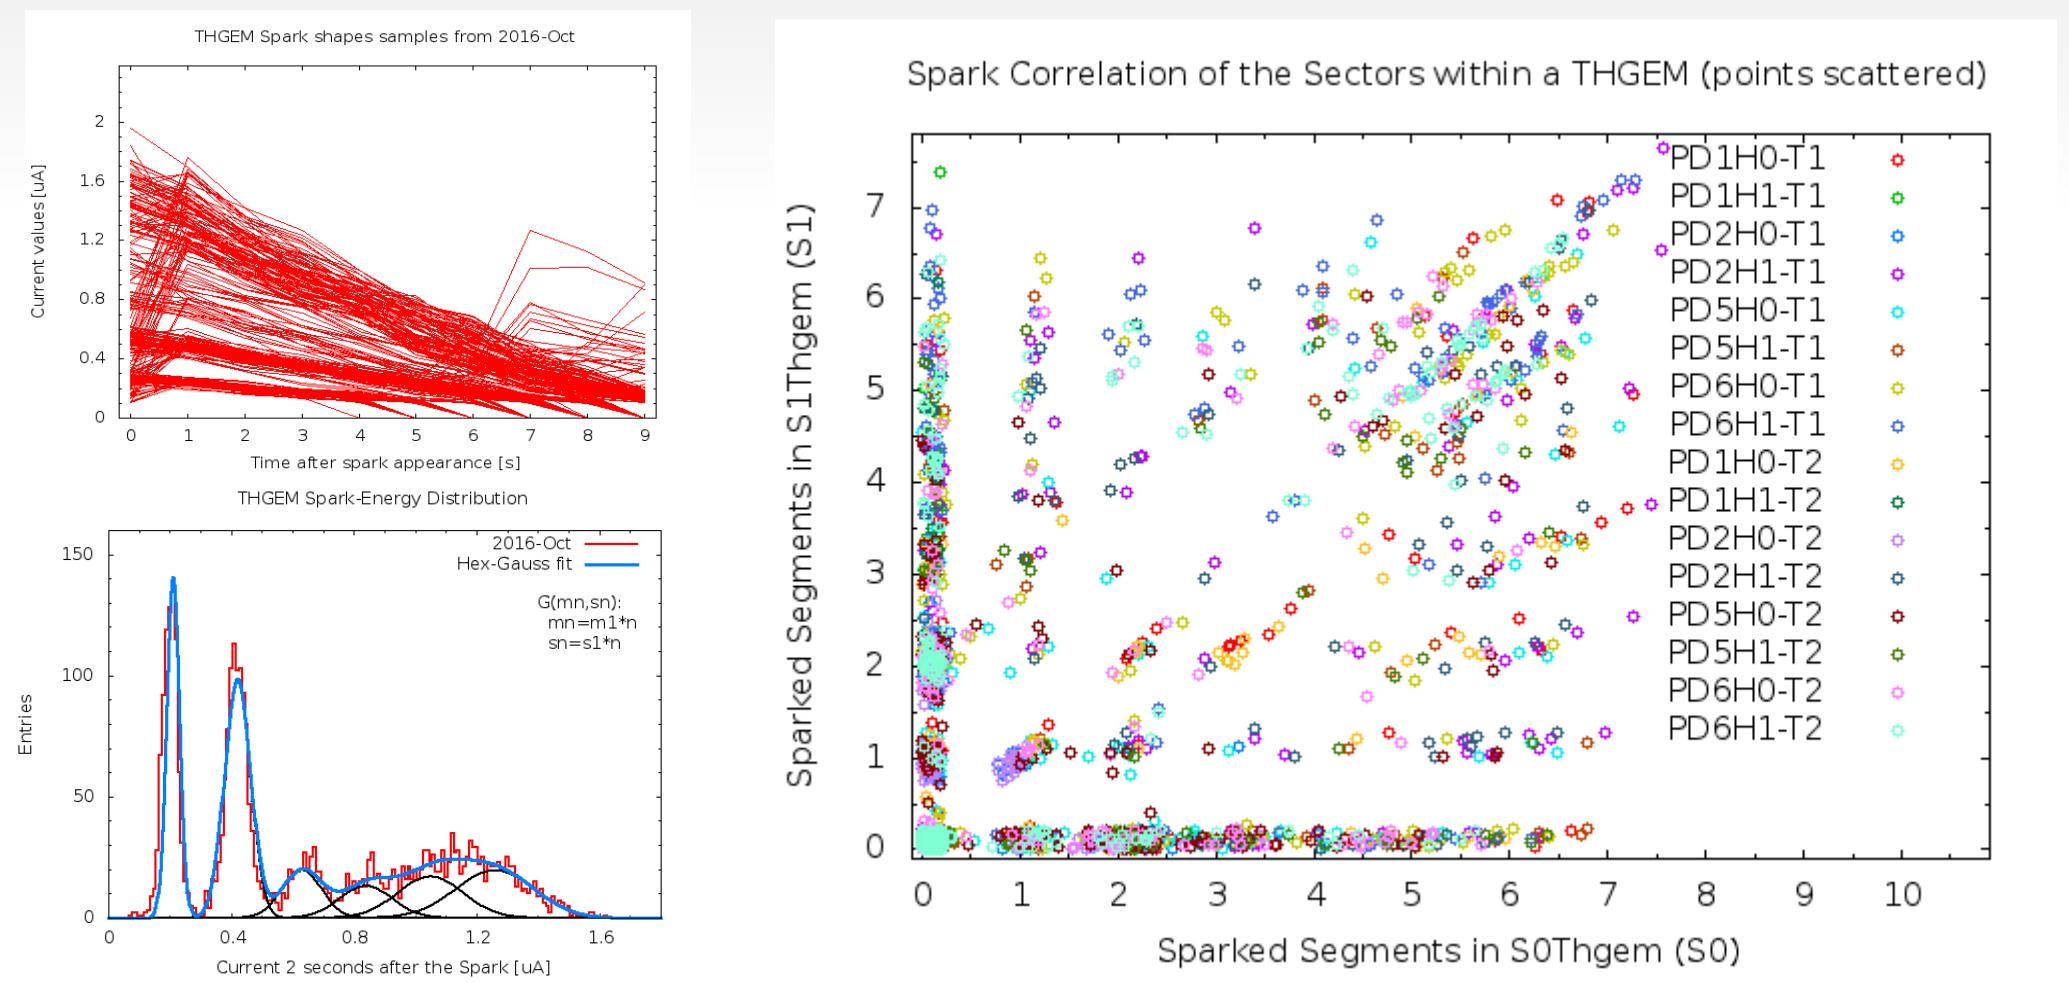
Sparks in the THGEMs

- Spark energy is measurable: is **discrete** → number of involved segments
- Spark correlations
 - between the two THGEMs of a Sector : always
 - between two sides of a THGEM (neighbouring Sectors)
- Mostly 1-2 segments, or the whole THGEM (showers?)

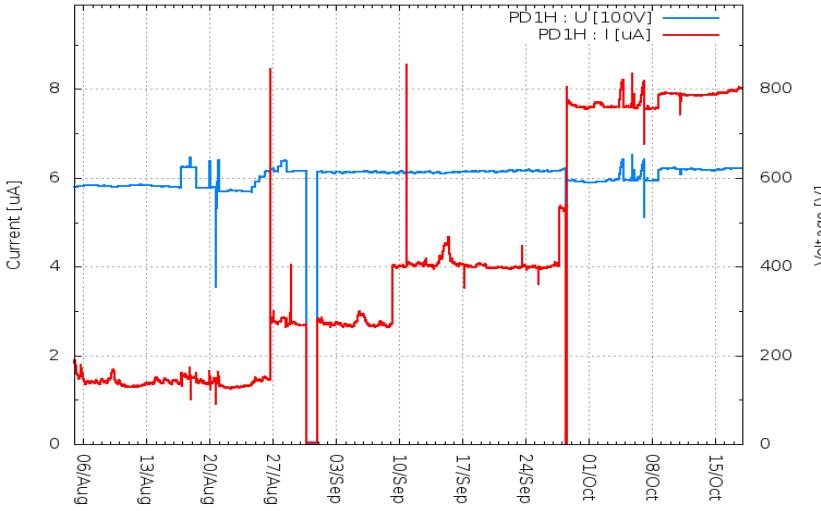
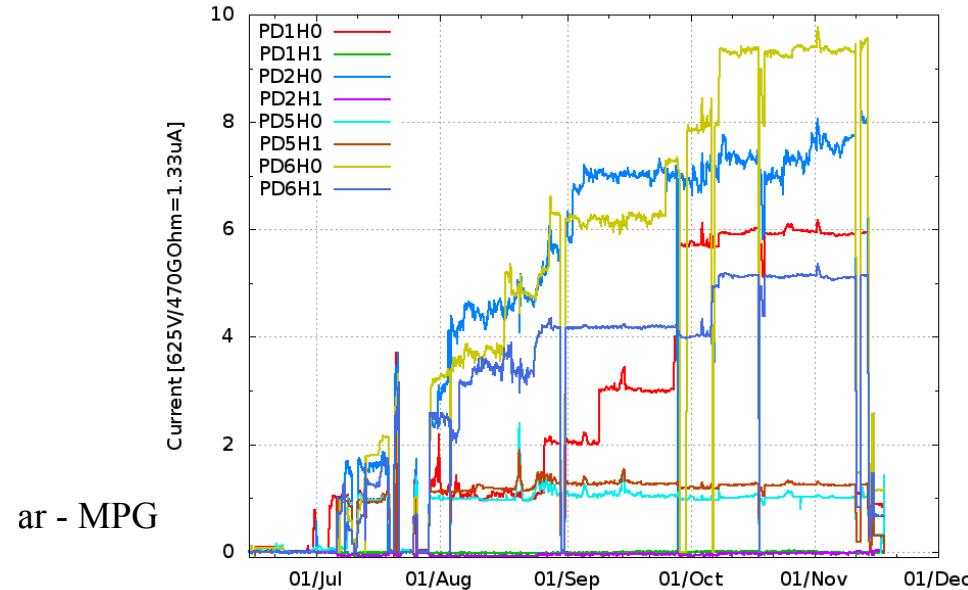
The Micromegas

- **Shorts** have appeared during operation
could be : inside the detector's gas volume / in the PCB material / resistor array
- **No pre-filter resistors** are used before the distribution to the HV-pads
→ **MM is still usable**, with high constant current (flowing to the shorted pad)
no extra noise have been seen due to these shorts
- Close-to **discrete steps** in currents (proportional to the number of shorted pads?)
 $\Delta I \sim 625V / 470M\Omega$
- The troublesome "super-cooling" (malfunction of a cooling regulator logic)
too cold environment → humidity got condensed: Issue solved asap
- Total number of affected pads: 30 (**0.15%**) + N₂ flux to resistors
Stable for more than a month (no new shorts from the 7th of October)

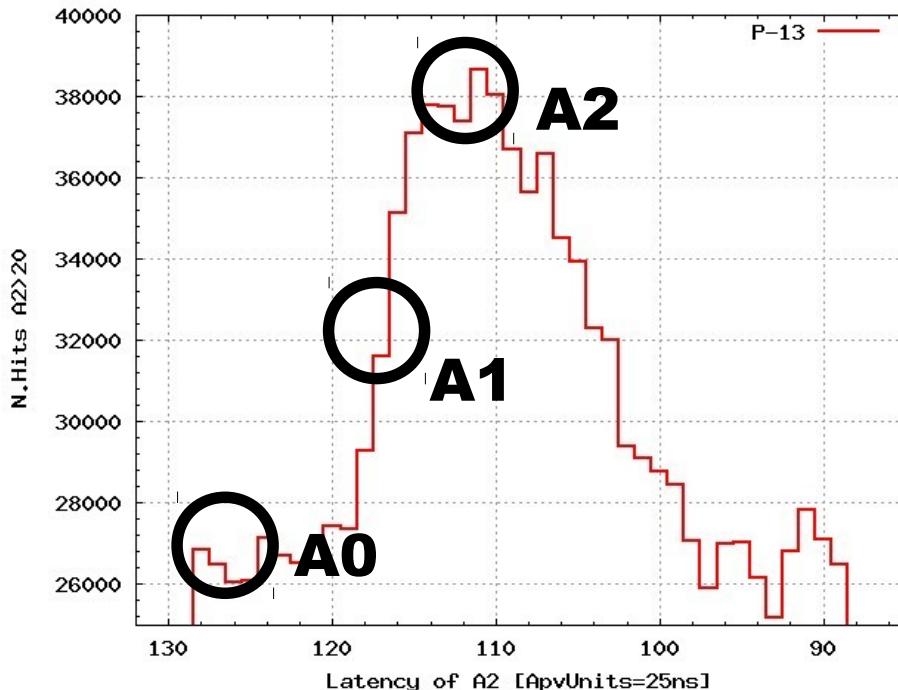
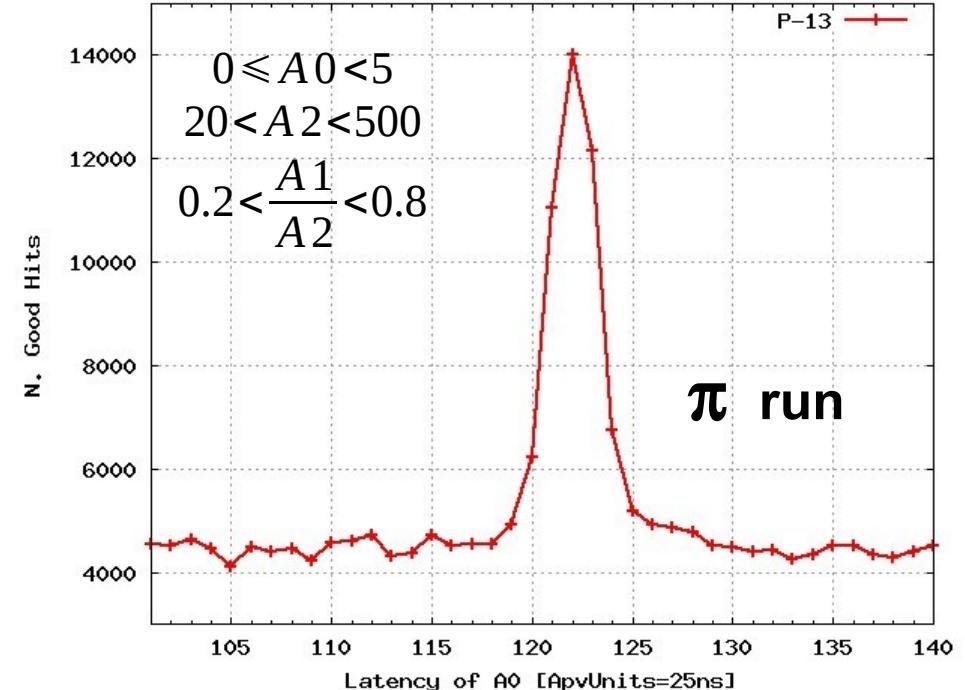
Readout with APV

- RICH FEE : APV25 + DAQ chain
 - integration, shaping, sampling, pedestal subt., zero sup., send data
- Latency settings depends on trigger system and signal formation
- **Latency scan** with several configurations (HV and beam) [LatencyUnit=25ns]
- Amplitude measurement in 3 samples, separated by 150ns
 - Baseline (A0), Rising edge (A1), Maximum (A2) [AdcUnit=300e]
- **Signal shape** is visible, short plateau at maximum, fast rise defines narrow timing
- **Clear indication on the presence of the signal !**

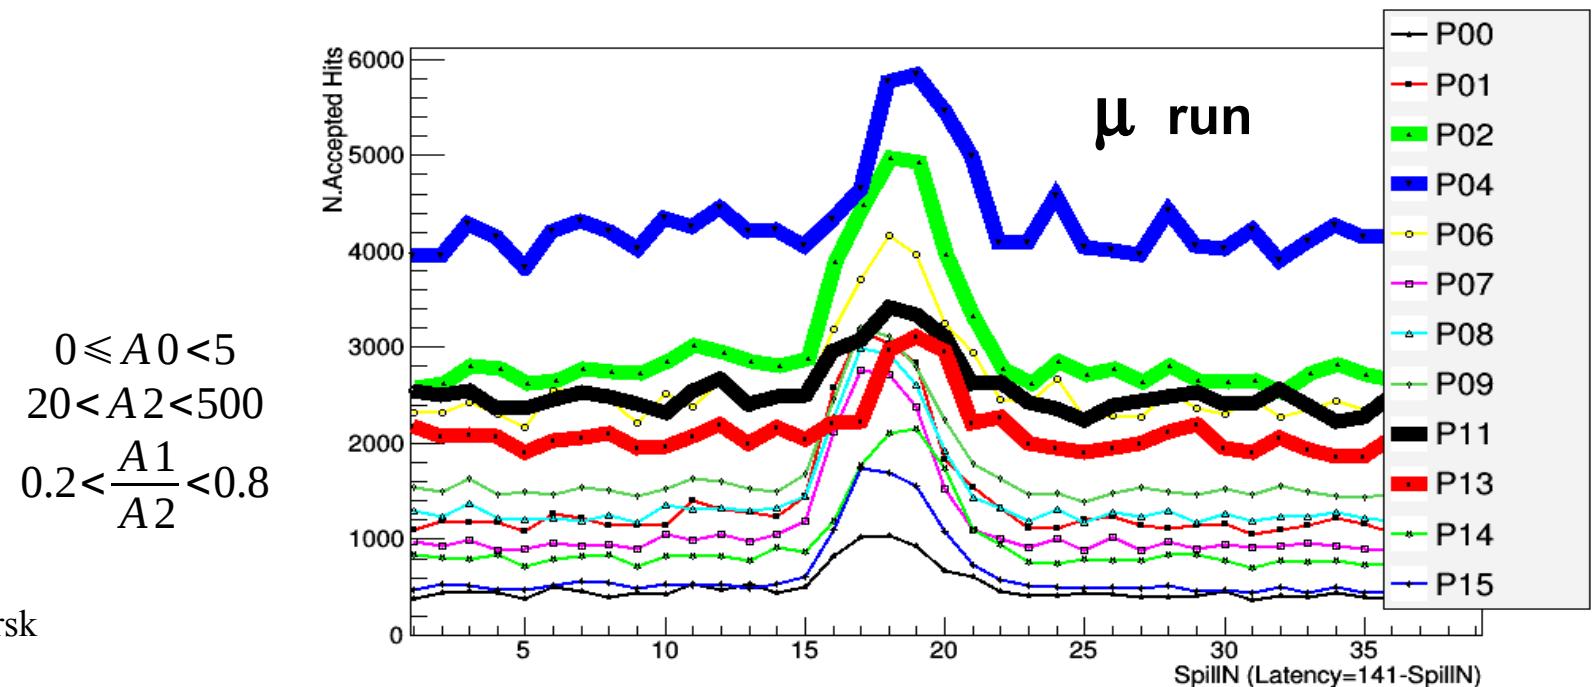
Readout with APV

- RICH FEE : APV25 + DAQ chain
 - integration, shaping, sampling, pedestal subt., zero sup., send data
- Latency settings depends on trigger system and signal formation
- **Latency scan** with several configurations (HV and beam) [LatencyUnit=25ns]
- Amplitude measurement in 3 samples, separated by 150ns
 - Baseline (A0), Rising edge (A1), Maximum (A2) [AdcUnit=300e]
- **Signal shape** is visible, short plateau at maximum, fast rise defines narrow timing
- **Clear indication on the presence of the signal !**

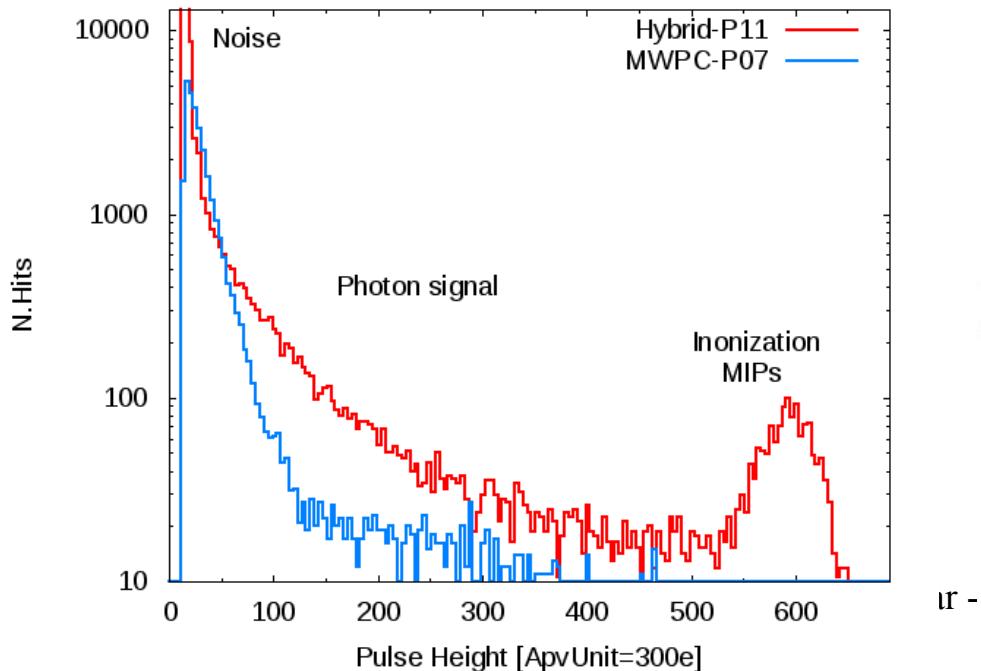
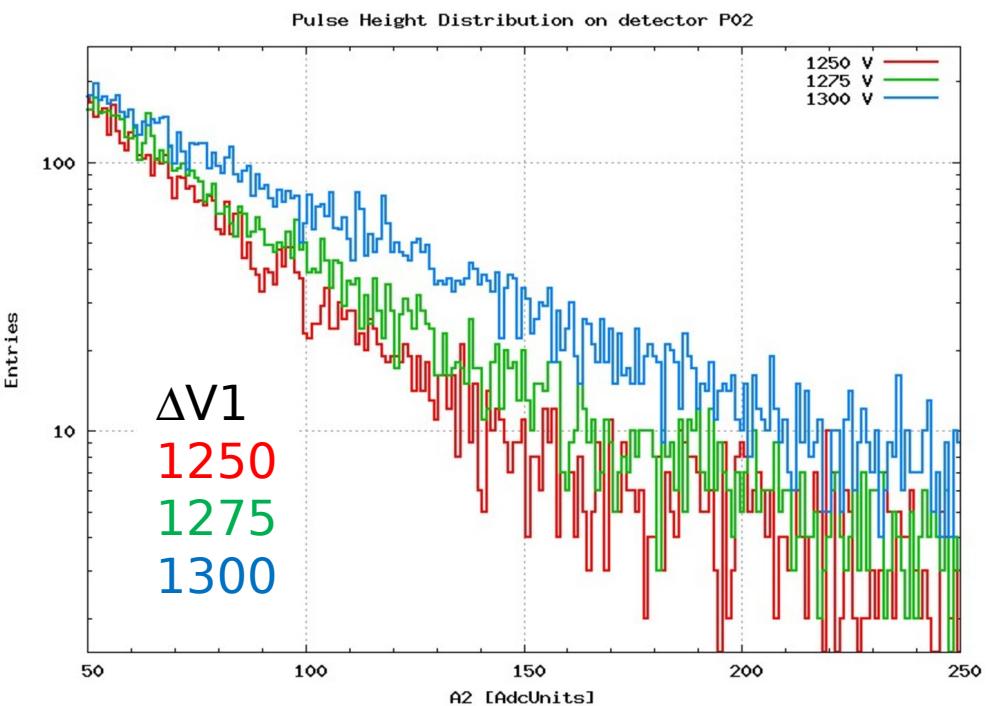
HV Scans

- **First characterization** steps during the commissioning
reproduce simple laboratory scans, check for consistency
- **Gain scan** wrt voltage on MM and THGEMs were checked
and influence of transverse fields, and gain sharing was studied as well
- Increase of the gain is **consistent** with the laboratory predictions
- **Gain of 10k-30k reached** (MWPC raw PH gain : 4-5k)
- Number of detected photoelectrons are similar as for MWPCs

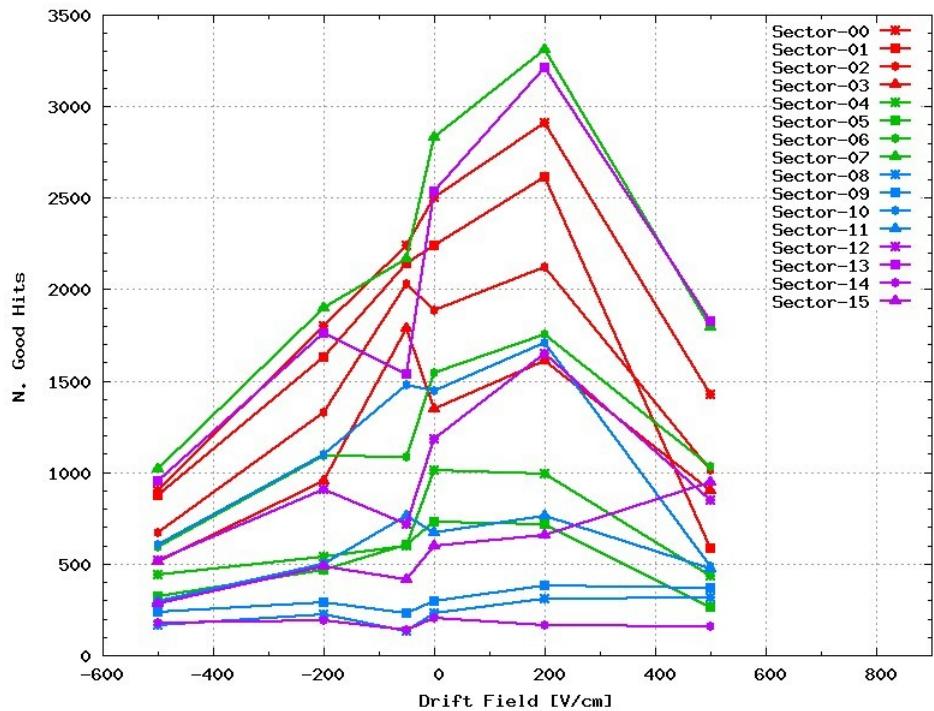
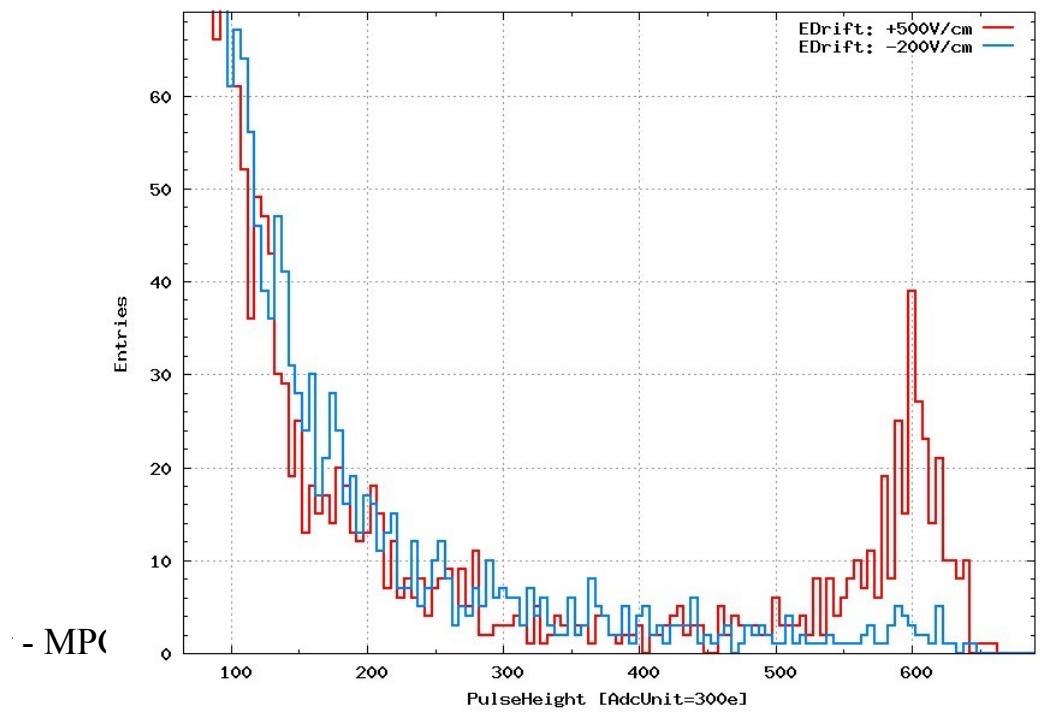
Drift Field

- Drift field scan was performed :
crosscheck the laboratory results, define optimal field
- Effect on **photo-electron yield** as expected
(thus even verifying that the photo-electrons were observed)
- **Suppression of MIP** (high charge) signal has been seen
(can increase stability, and usable dynamic range)
- Optimum chosen at maximal photo-electron yield

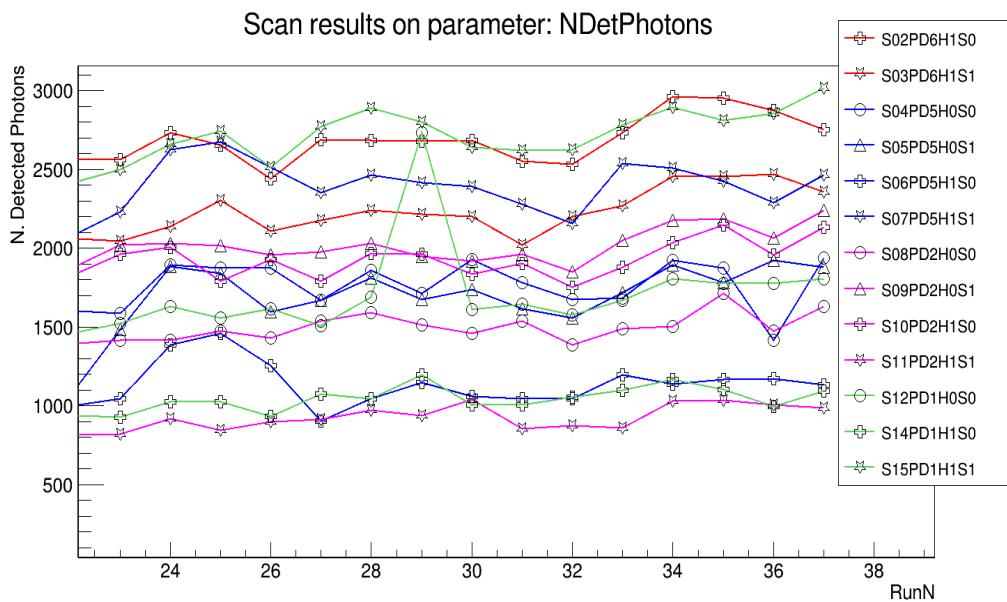
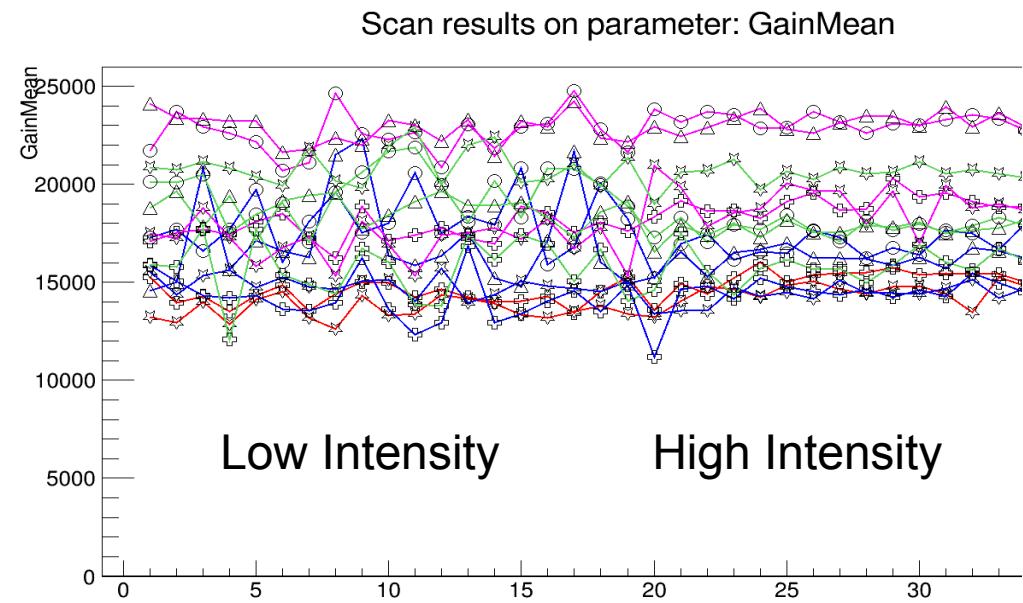
Stable Operation

- Performance stability investigation
 - Stable operation (no parameter modification at all) for the last week of RUN2016
- Close-to optimal configuration (gain and stability)
- Spark rate in average was below **5 / day / Sector**
- **Stable** gain in Low/High intensity as well
- Offline work is ongoing ...

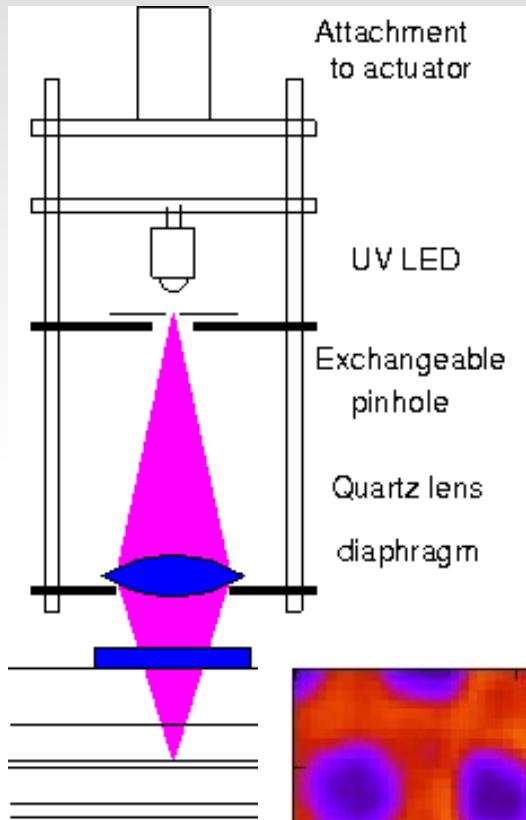
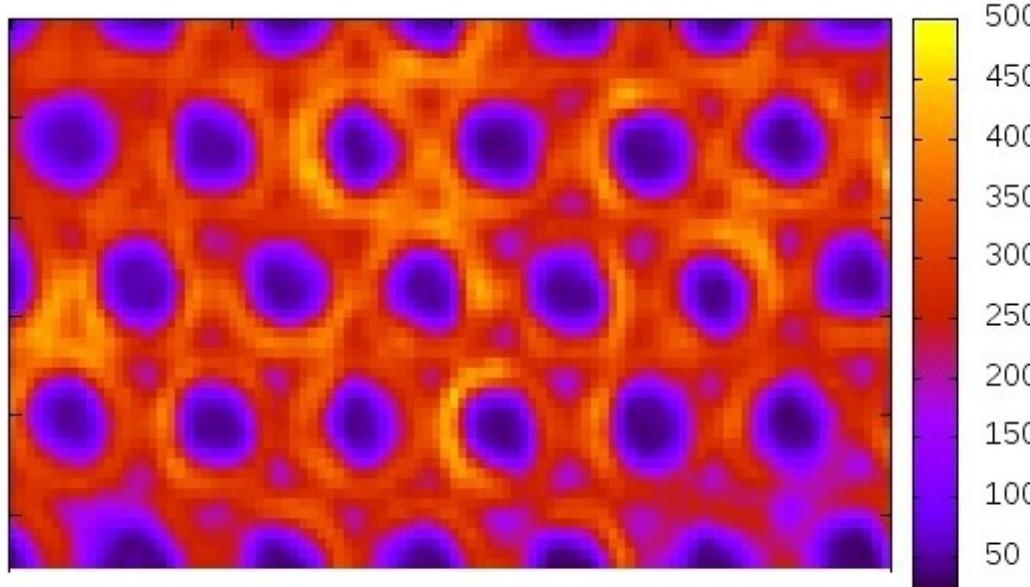
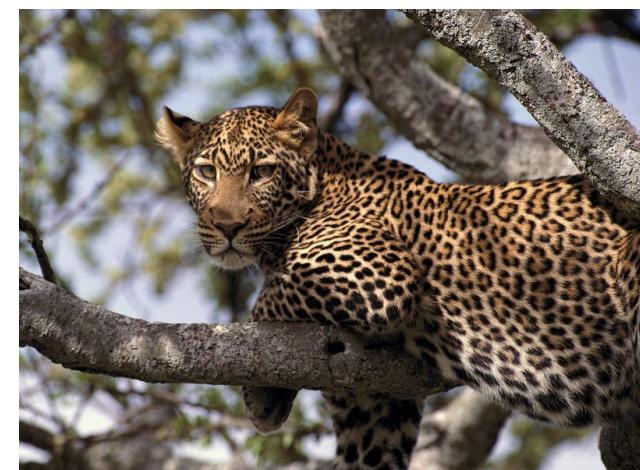
The "Leopard"

- Pulsed UV light focused to 70 µm spot onto the top of the ThickGEM
- Optical setup mounted onto a controlled 3D actuator system
- Fast DAQ...
- Single PE spectra at each point
-> Photo-efficiency, and gain

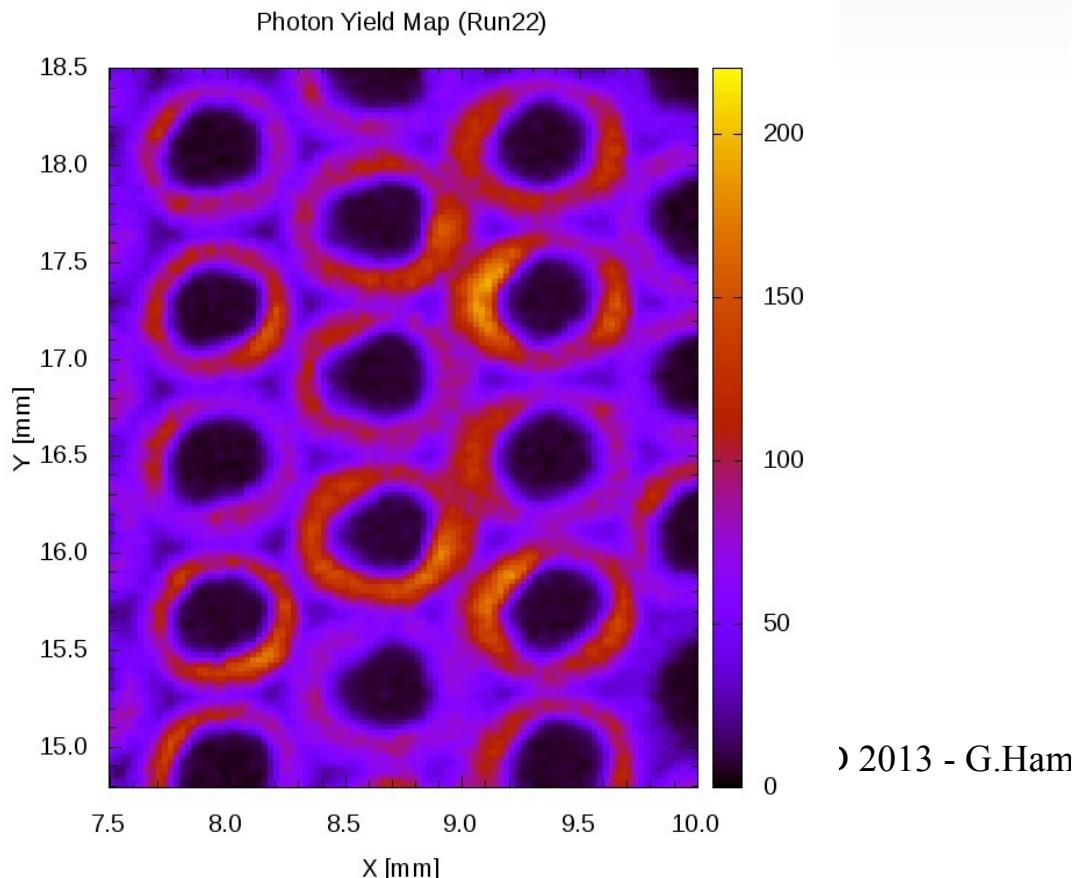
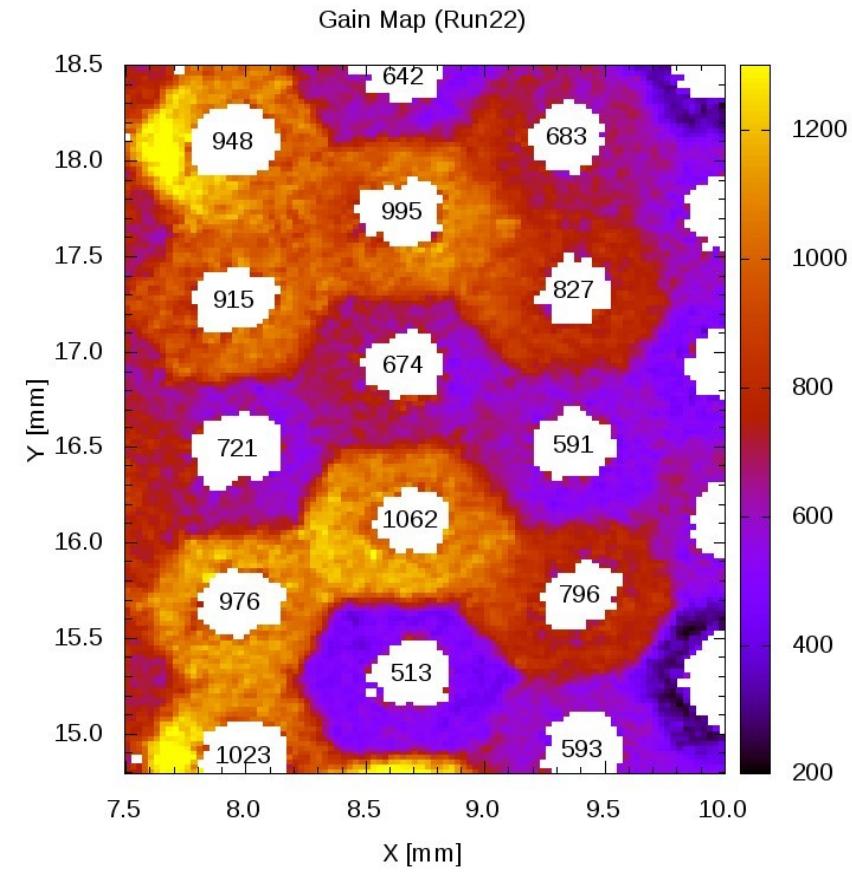
Maps of Yield and Gain

- Microstructure of the photo-efficiency map
- Appearance of the "hole-gain"
- Non-uniformity on the hole-to-hole level
