MPGD Photon Detector Upgrade for COMPASS RICH

Gergő Hamar

Instrumentation for Colliding Beam Physics
Budker INP, Novosibirsk, 2017

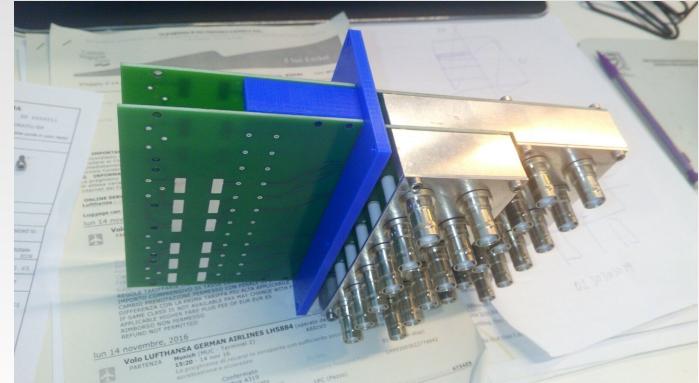
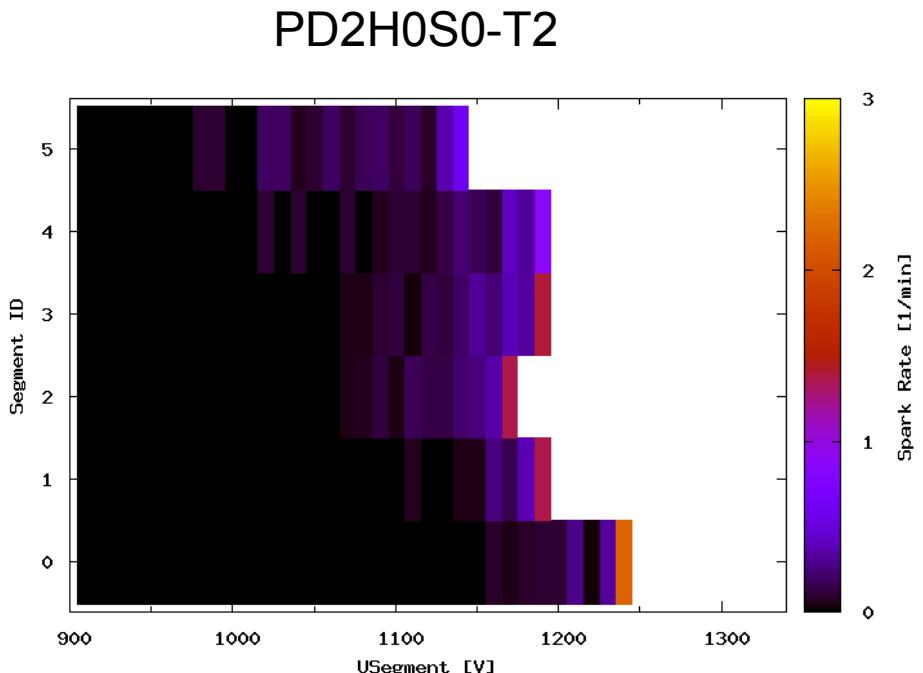
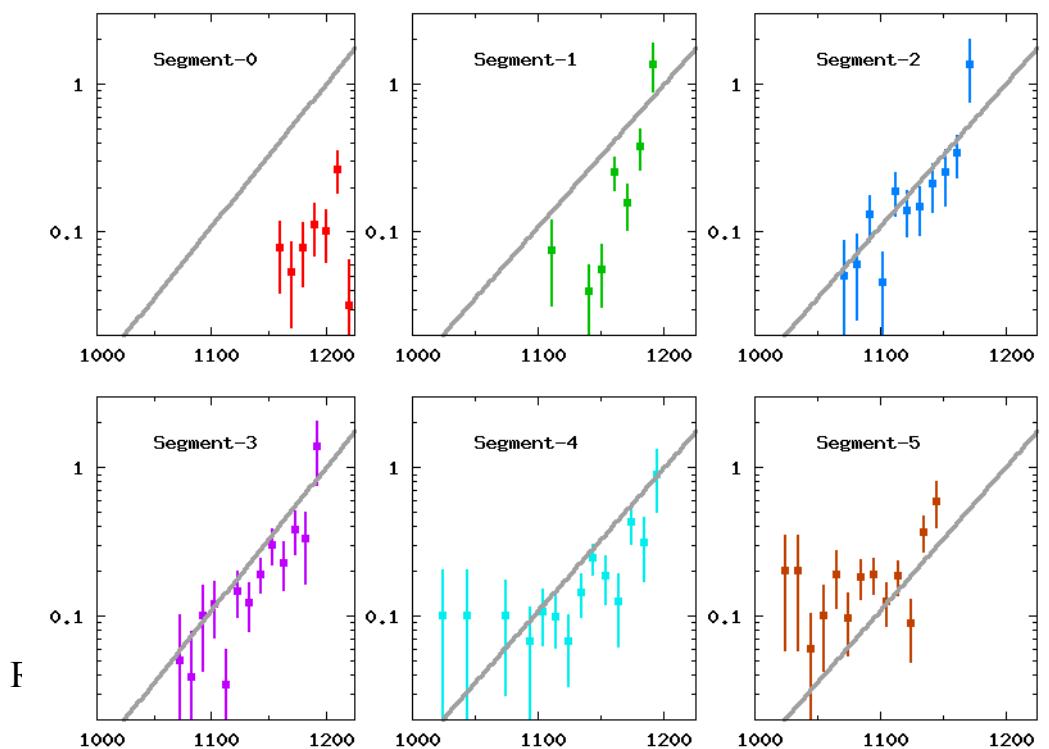
After End of RUN2016 Segment Check

- The feeble Sectors will be investigated
 - Spark rate measurement at Segment level**
(24mm wide strips means 4% of a detector)
- Weak segments** can be **identified** and later if needed eliminated
- Testing has been started, and foreseen to continue during the next weeks
