# Rotation Target R and D of ILC E-driven source

**T. Omori (KEK), 20-September-2017**

**2017 POSIPOL 2017**

## R/D of the Slow Rotation Target of the Conventional $e^+$ Source for ILC

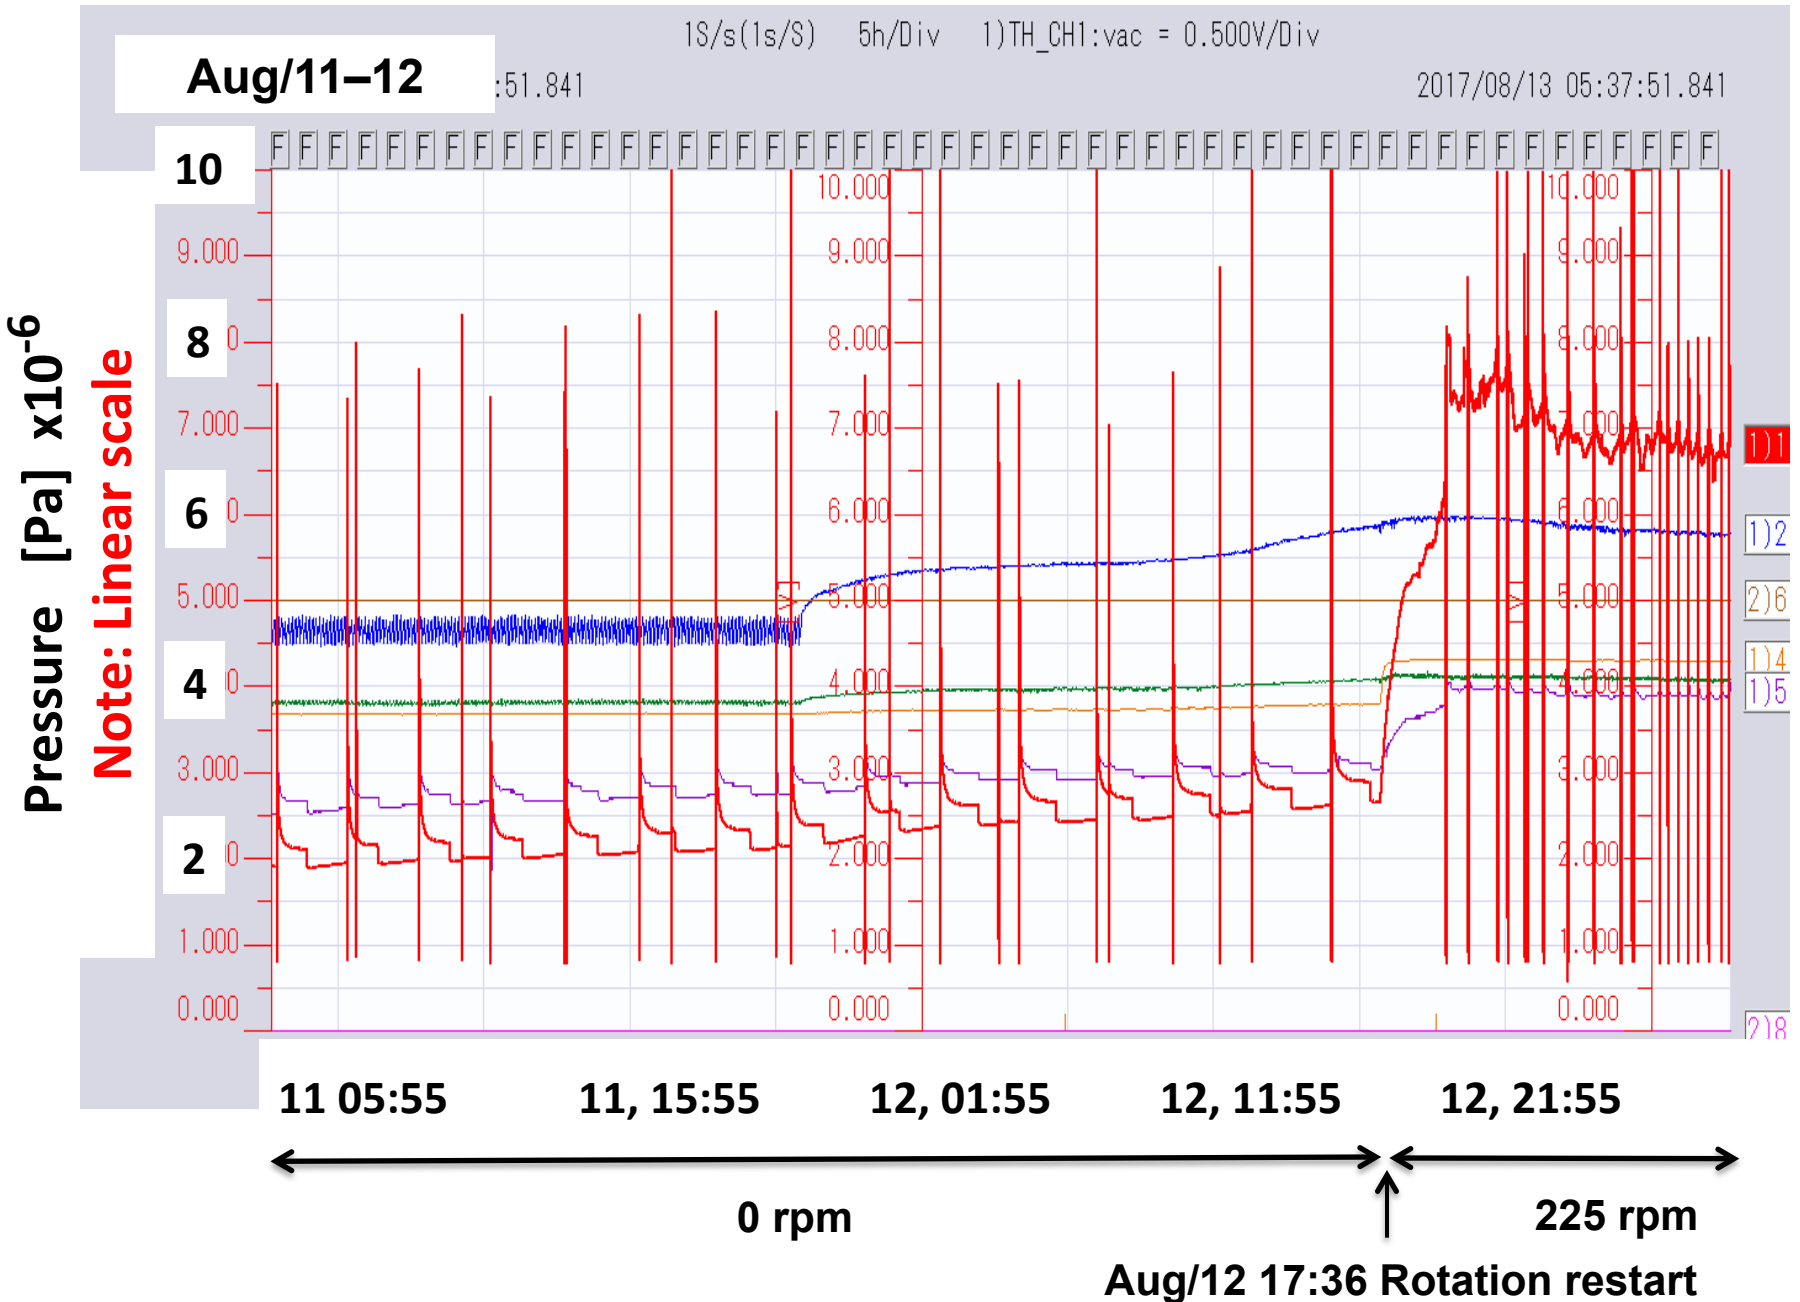
# Vacuum Test: Afer reinstallation

- **Reinstallation of the seal unit: 31<sup>st</sup> July**
- **KEK scheduled power shut down: 5<sup>th</sup>-6<sup>th</sup>, Aug.**
- **Air-conditioner of the room broken: 9<sup>th</sup> Aug.**
  - **NOT scheduled.**
  - **New air-conditioner was installed in the middle of September.**
  - **Experiment after the reinstallation was performed in no good environment**
- **KEK Summer Holidays: 11<sup>th</sup>-16<sup>th</sup>, Aug.**
- **We observed spikes again in the operation after the reinstallation.**

- We observed spikes again in the operation after the reinstallation.
- Spikes appeared **immediately** after restart of operation.  
cf. Spikes appeared **after 3 months** of operation in the first experiment in February-July).
- In the first experiment, we suspected the aging of the ferrofluid was the cause of the spikes. But in the second experiment we observed spikes immediately.
- Quality control is the cause?.
